NMPSIA
Espanola Public Schools
Tony E. Quintana Elementary School
Loss Control & Safety Audit

This report contains the findings of an independent Loss Control & Safety Audit of Tony E. Quintana Elementary School. The audit was conducted on March 6, 2014, on behalf of the Espanola Public Schools, and at the request of NMPSIA.

GENERAL CONDITIONS INSPECTION**Contact:** Yanira Vasquez, Principal**Auditor:** James Dorn**Member Agency:** Espanola Public Schools**Client:** NMPSIA**Inspection Concluded:** March 6, 2014

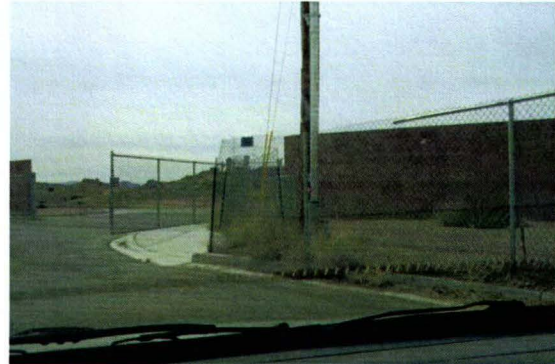
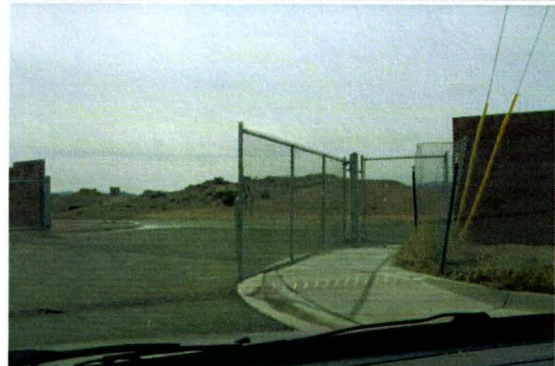
Recommendation Number: 2014-001

- Portions of the fence were not completed.
- The fence conditions pose attractive nuisance and injury hazards.

- Incomplete fencing should be repaired.

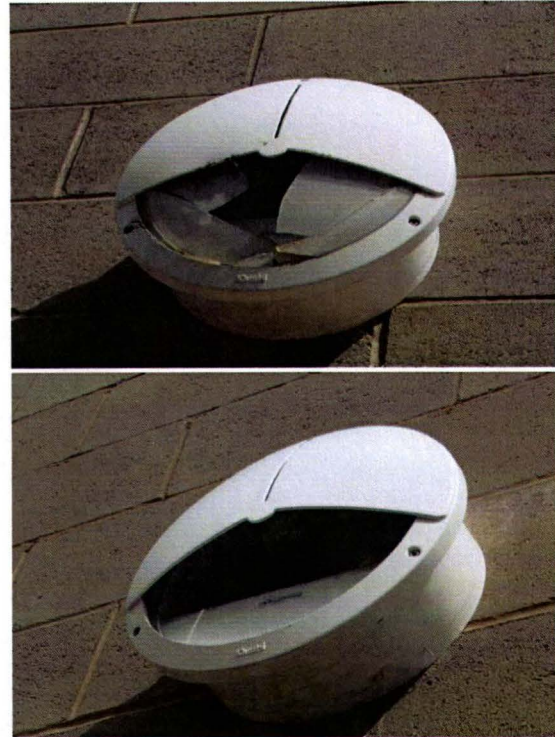
Recommendation Number: 2014-002

- Some of the light fixtures were broken.

- The light fixtures throughout the site should be inspected and repaired as necessary to ensure that proper lighting is provided.

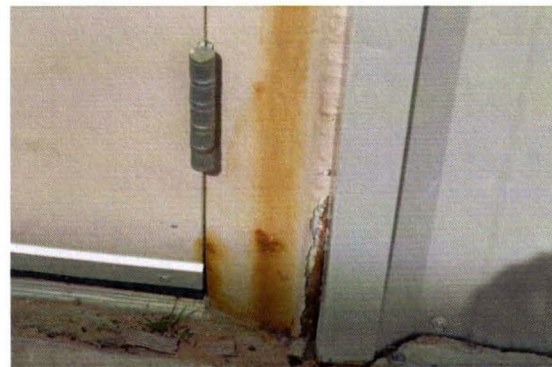
Recommendation Number: 2014-003

- Door frames were rusting and/or deteriorated.

- The damaged door frames should be repaired and/or replaced.
- Door frames should be inspected, repaired and/or replaced on a regular basis to ensure that they function properly and provide adequate security.
- Any construction alterations should be designed and supervised by a person with expertise in building code requirements.

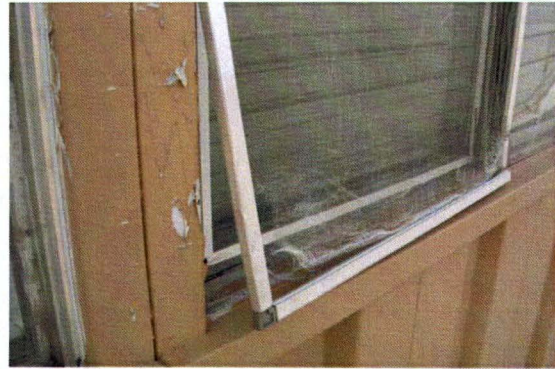
Recommendation Number: 2014-004**Observations:**

- Damaged window screens were observed.
- The damaged screens pose an attractive nuisance and potential for injury.

- The damaged screens should be repaired or replaced.

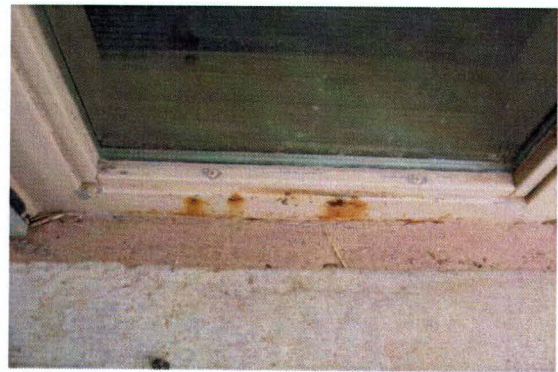
**Recommendation Number: 2014-005****Observations:**

- Window frames were rusting and/or deteriorated.

- The damaged frames should be repaired and/or replaced.
- Frames should be inspected, repaired and/or replaced on a regular basis to ensure that they function properly and provide adequate security.
- Any construction alterations should be designed and supervised by a person with expertise in building code requirements.

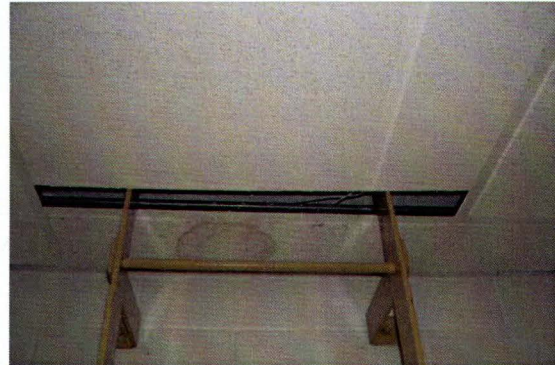
4. Was the building free of apparent leaks or other obvious water intrusion?**Recommendation Number: 2014-006****Observations:**

- Evidence of leaks and/or other water intrusion was present.
- Water intrusion and the presence of moisture in building materials can foster the growth of mold and mildew.

- The source of the water intrusion should be determined and corrective action taken to prevent recurrence.
- Wall coverings, ceiling tiles, floor coverings, and wall and ceiling insulation should be inspected to identify the presence of damage or mold growth. Both exposed and concealed surfaces should be inspected.
- Damaged and contaminated materials should be removed and disposed of in a way that prevents their continued use.
- The entire damaged or contaminated area should be cleaned and disinfected with an effective fungicide prior to installing new materials.

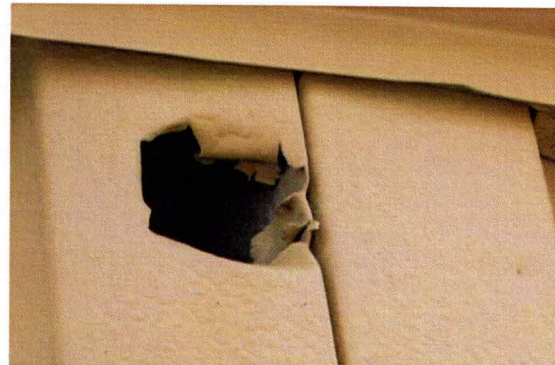
5. Do walls and ceilings appear to be of an appropriate type and condition?**Recommendation Number: 2014-007****Observations:**

- Holes and/or unprotected penetrations were present in some of the walls and/or ceilings.
- The openings in the walls compromise structural fire safety and provide an entry point for insects and vermin.

- The holes should be properly sealed with approved materials.

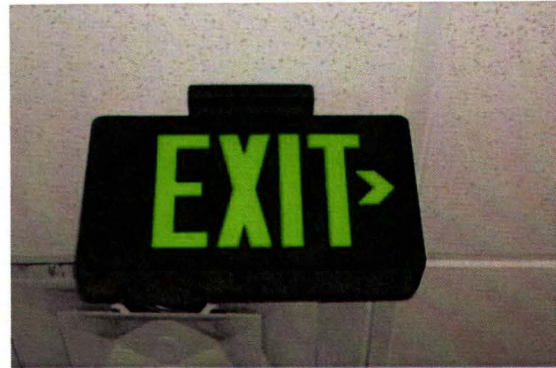
Recommendation Number: 2014-008

- One or more of the illuminated exit signs were not illuminated; therefore, we could not determine if they were fully functional.

- Exit signs should be inspected on a regular basis to ensure that they are functional at all times.

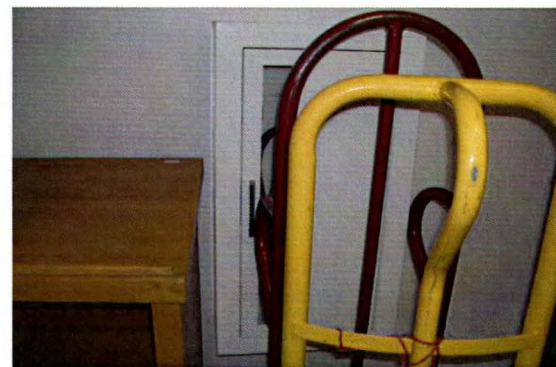
Recommendation Number: 2014-009

- Fire extinguishers were obstructed. Obstructing fire response equipment delays or prevents access in an emergency.

- Fire extinguishers should not be obstructed. A clear path to fire extinguishers should be maintained.
- Approved fire extinguishers should be mounted, located, and identified so that they are readily accessible to employees at all times.

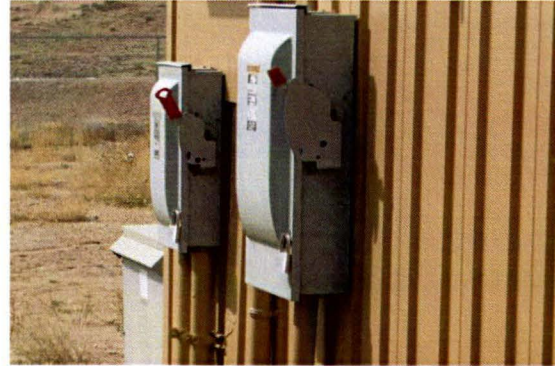
Recommendation Number: 2014-010

- The boxes were not locked to prevent unauthorized access.

- All exterior utility controls should be covered and locked, or otherwise controlled, to prevent unauthorized access.

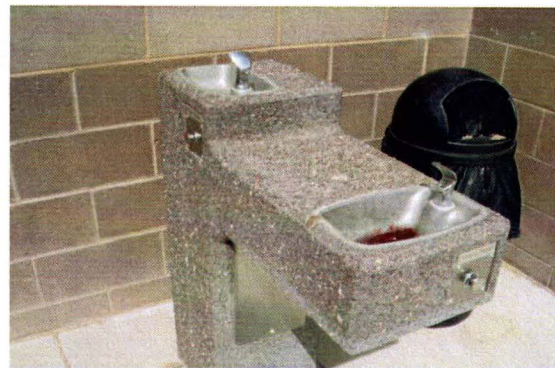
**11. Are plumbing systems and fixtures in good condition and free from damage or leaking?****Recommendation Number: 2014-013****Observations:**

- One or more of the drinking fountains were inoperative.

- Inoperative drinking fountains should be repaired as necessary.

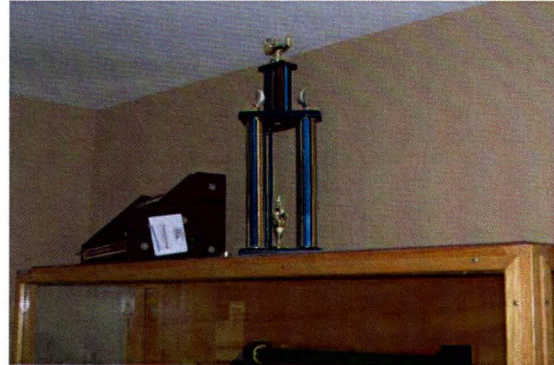
Recommendation Number: 2014-014

- Some of the trophies stored overhead were not secured.
- These unsecured items pose falling object hazards.

- Stored items should not create a hazard. Items should be shelved or racked in a manner designed to prevent them from tipping, falling, collapsing, rolling, or spreading.
- Racks, bins, planks, sleepers, bars, strips, blocks, and/or sheets should be used where necessary to make storage stable.
- Velcro, mounting putty, glue, or some other type of device should be used to secure large and/or heavy items stored overhead in public assembly areas and classrooms. Securing the items will prevent a falling object hazard during seismic activity. If the items cannot be secured, they should be removed.

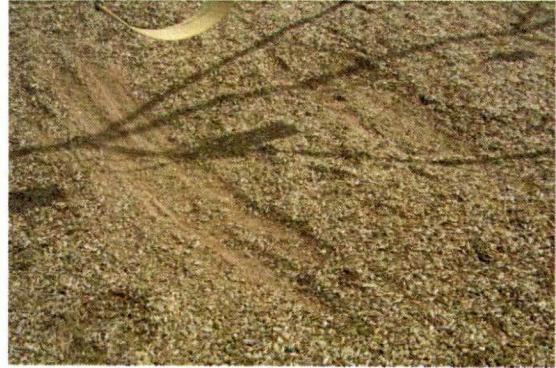
Recommendation Number: 2014-017

- The protective surfacing around and under the equipment was of an insufficient depth in some areas of the use zone and/or it did not extend throughout the entire use zone of the equipment.

- Protective surfacing should be installed and maintained throughout the entire use zone of the equipment being protected.
- The protective surfacing should be maintained in all areas of the equipment use zone so that it provides adequate protection for the maximum height of the equipment.
- The depth of the protective surfacing should be monitored and topped off as needed to ensure that it retains a fall height value equal to or greater than the fall height of the protected equipment.
